Manhole Inspection Summary

Manhole # S35OO1006MH

Insp Date: **3/14/07 11:27 AM**

Location Address: **4808 NORWOOD RD**

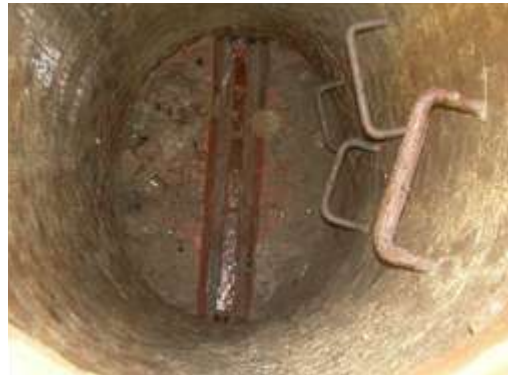
Top View

Steps Count: **4** Missing: **0** ☒ **Corroded**

Surcharge ☒ **Evidence Of Surcharge** Depth: **1** (ft.) ☐ Active Surcharge Present

Corroded steps. Evidence of surcharge - Bench debris.

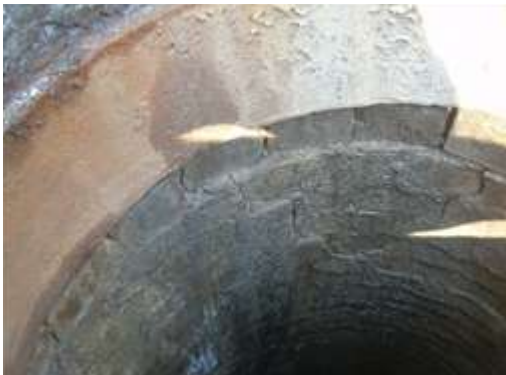
Defect

Frame Offset: **0** (in.) Condition: ☐ Sound ☐ Cracked ☒ **Leaks**

Condition: ☐ Sound ☐ Cracked ☐ Root Intrusion ☐ Loose Brick ☒ **Deteriorated**

Infiltration: ☐ None ☒ **Joint** ☐ Cracks ☐ Mortar ☐ Roots ☒ **Wall**

Frame leaks. Corbel deterioration and infiltration.

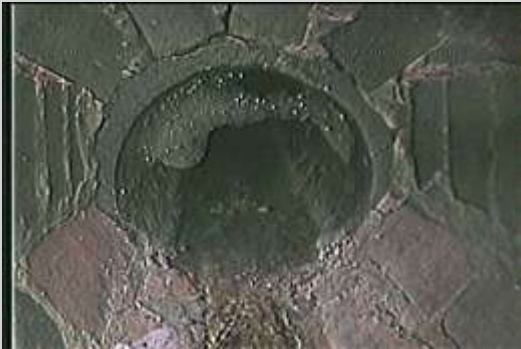
Pipe Out @ 12 O'Clock

Infiltration: **None** Pipe Seal Cond: **Unknown**

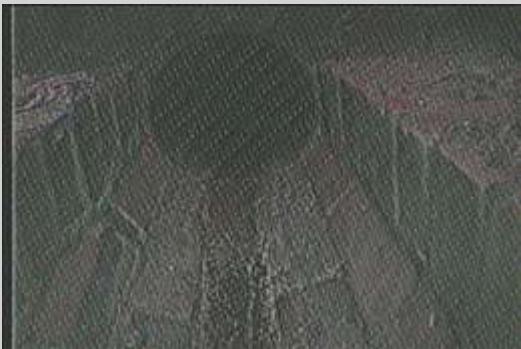
Pipe In @ 6 O'Clock

Infiltration: **None** Pipe Seal Cond: **Cracked**
